SUBJECT: RAPID RESPONSE TRANSMITTAL / SERVICE ACTION #10-010
Propeller Shaft Balance Weights Missing Or Inadequately Welded

2010 (LX) Chrysler 300/Dodge Charger

NOTE: This Rapid Response Transmittal applies to All Wheel Drive (AWD) vehicles only (Body Models LXE*48 and LXF*48).

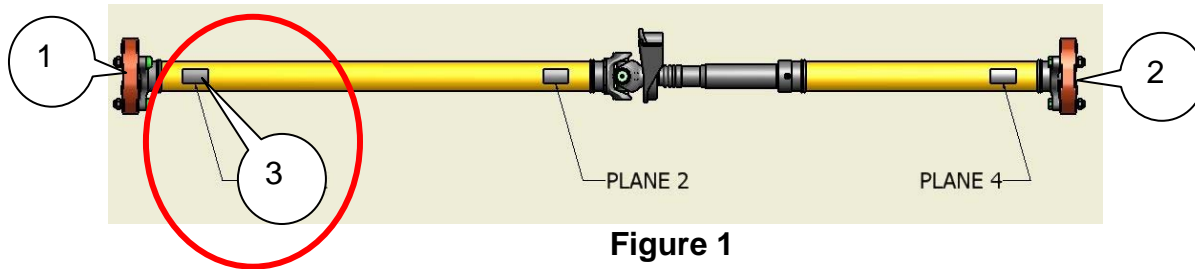
Figure 1

1. Place vehicle on a lift, place gearshift in neutral and raise the vehicle.
2. Inspect the propeller shaft for the presence of a spot welded balance weight at "Plane # 1", (Fig 1).

1	Rear Propeller Shaft Rear Axle Mounting Flange
2	Rear Propeller Shaft Transmission Mounting Flange
3	Plane # 1

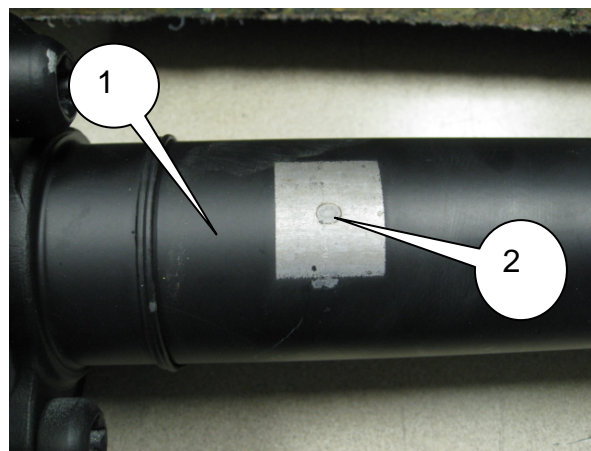
Figure 2

3. If a bare metal area is found as shown (Fig 2), proceed to step 8 “Replacing the Propeller Shaft Assembly.” If not proceed to the next step.

1	Propeller Shaft
2	Balance Weight Missing (Bare Metal)

- Replace the propeller shaft assembly. Follow the procedures outlined in DealerCONNECT>TechCONNECT>03 – Differential and Driveline>Propeller Shaft>Removal/Installation>Rear.

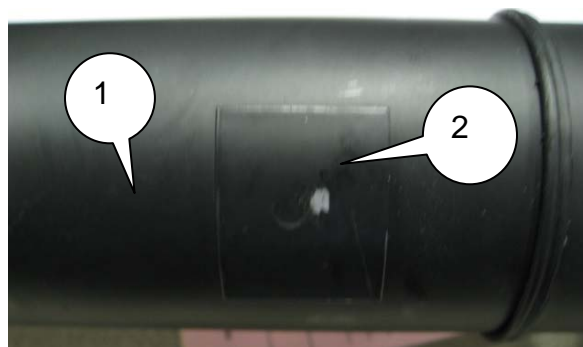
Figure 3

4. If no balance weight exists and there is **no bare metal** as shown (Fig 2), the inspection process is complete and it **WILL NOT** be necessary to replace the propeller shaft.
 5. If a balance weight is found (Fig 3), proceed to the next step.

1	Propeller Shaft
2	Balance Weight

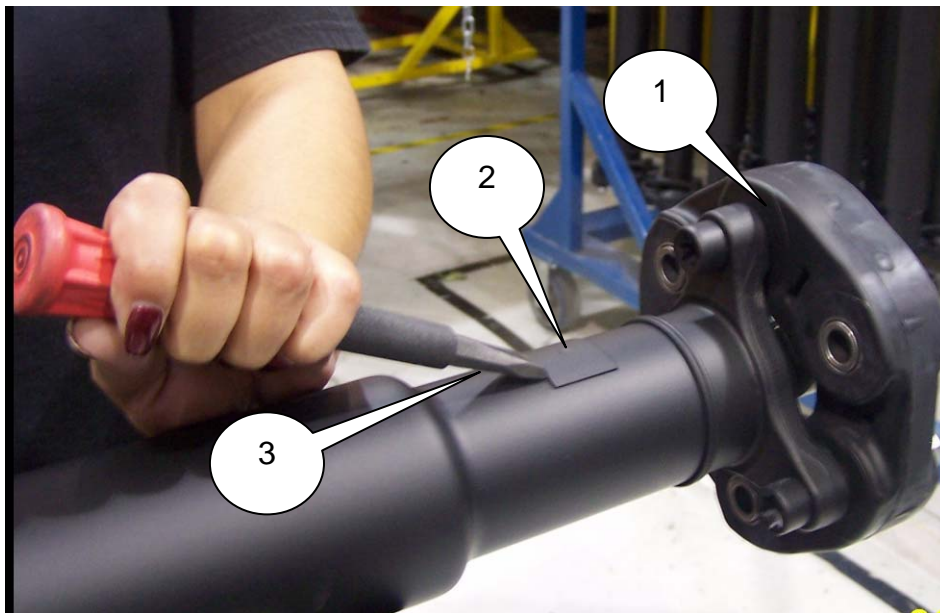
Figure 4 (Shaft Removed for Picture Clarity)

6. Test the integrity of the spot weld as follows:
 - a. Rotate the propeller shaft so that the balance weight is facing downward.
 - b. Center the edge of a chisel on the edge of the balance weight at a 45° angle (Fig 4).

- c. Using a two pound rubber or plastic mallet placed 6 inches from the chisel, strike the head of the chisel. If the balance weight becomes dislodged, cupped, torn, or shifted, proceed to step 8 “Replacing the Propeller Shaft Assembly.”

1	Rear Propeller Shaft Rear Axle Mounting Flange
2	Propeller Shaft Balance Weight
3	Chisel Positioned at a 45 Degree Angle

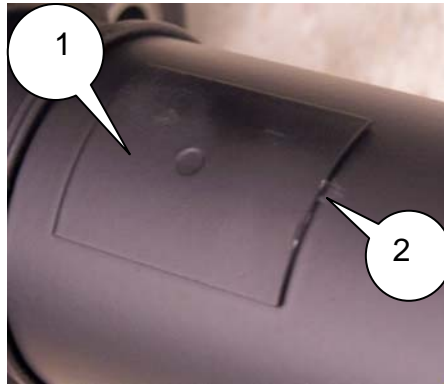
Figure 5

1	Propeller Shaft Balance Weight
2	Touch Up Balance Weight at Strike Areas

7. If the weight is firmly attached, touch up the weight with flat black paint as necessary (Fig 5). The inspection process is complete and it **WILL NOT** be necessary to replace the propeller shaft.
