February 2011

Customer Satisfaction Notification K39 Transmission Shifter Interlock Lever

2007 (LX) Dodge Charger, Magnum and Chrysler 300

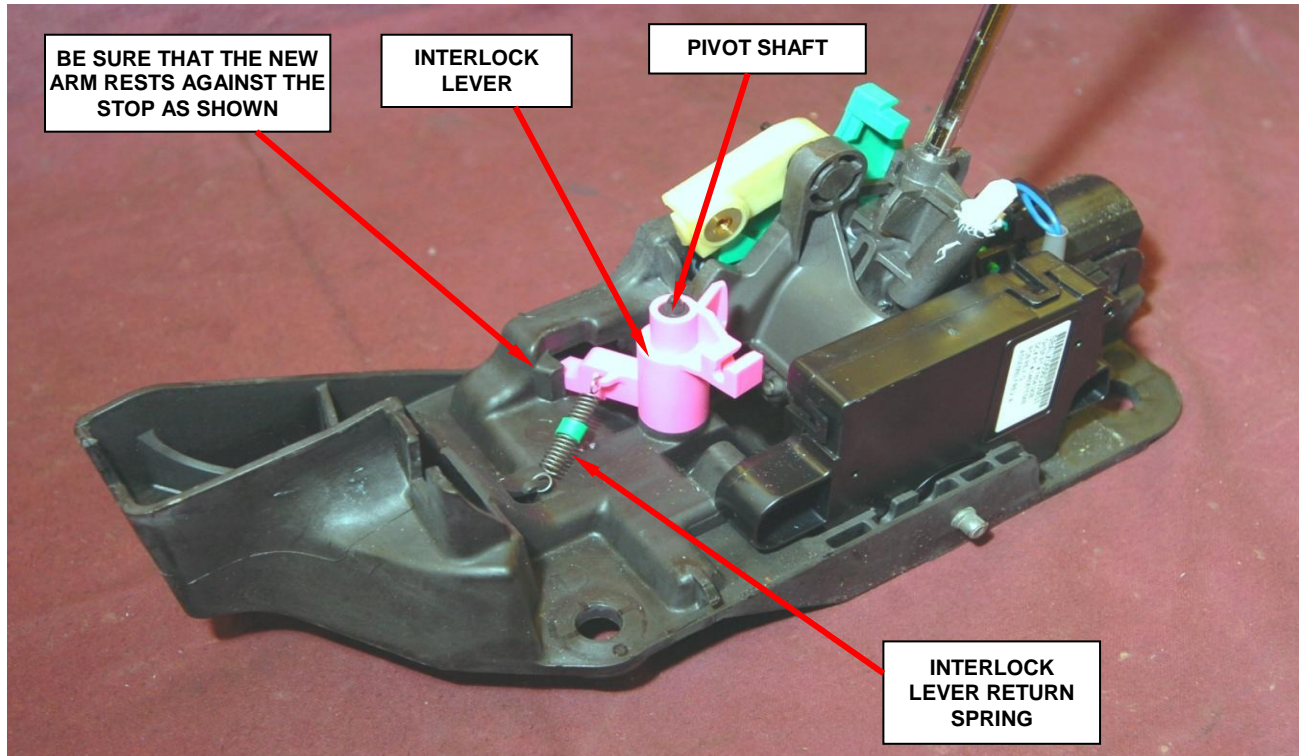
Figure 6 – Interlock Lever and Interlock Lever Return Spring

The transmission gear shift lever interlock return spring hook on about 28,800 of the above vehicles may break. A broken interlock return spring hook will result in the inability to move the gear shift lever out of the "PARK" position.

23. Disconnect the interlock lever return spring at the pivot arm (Figure 5).
24. Remove and discard the pink interlock lever.
25. Install the new interlock lever onto the pivot shaft.
CAUTION: Do not apply any type of lubricant to the pivot shaft.
26. Connect the interlock lever return spring.
27. Place the upper shift housing into position and connect the electrical connector located inside the shifter assembly.
28. Snap the upper shift housing into place on the lower shift housing.
CAUTION: The shifter must not be in the “PARK” position when assembling the shifter.
29. Place the shifter assembly back into the vehicle.
