SUBJECT: RAPID RESPONSE TRANSMITTAL #08-070 Rev. A
Lower Control Arm (LCA) to Crossmember Mounting Bolts

2008 - 2009 (MK) Compass/Patriot

2008 - 2009 (PM) Caliber

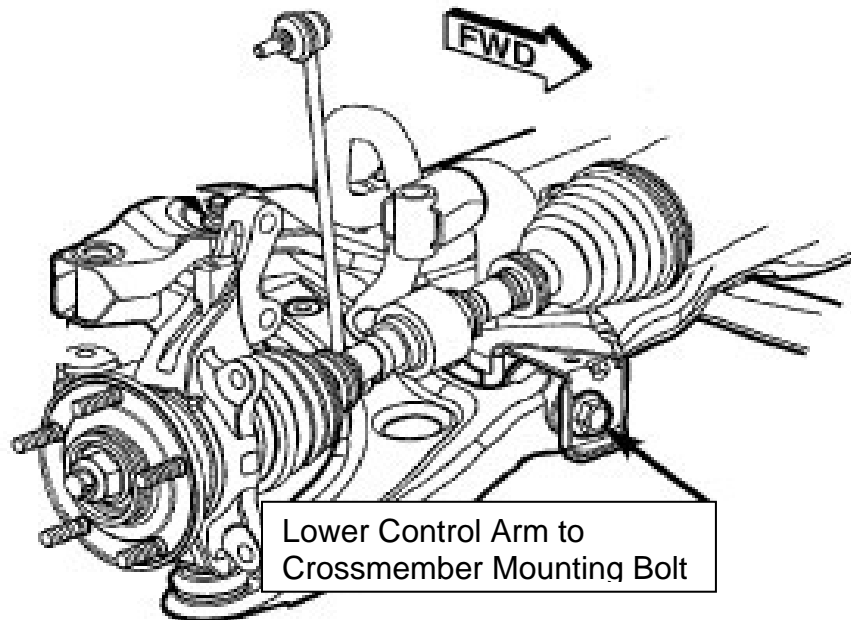
Figure 1 – Lower Control Arm Crossmember Mounting Bolt

A number of vehicles may have been shipped with front lower control arm to crossmember mounting bolts that may not be tightened to proper specification. This can lead to a popping or snapping sound on bumps.

1. Place the vehicle on a suitable lift and raise vehicle high enough to service front lower control arm to crossmember mounting bolts.
2. Remove belly pan (if equipped).
3. ****Replace lower control arm to crossmember mounting bolts with new flange bolt p/n 06509096AA (Fig 1). ****
4. Torque new flange bolt to 150 Nm (111 ft. lbs.).
5. Install belly pan (if equipped).
6. Check front alignment and steering wheel centering.

1. Place the vehicle on a suitable lift and raise vehicle high enough to service front lower control arm to crossmember mounting bolts.
2. Remove belly pan (if equipped).
3. Replace lower control arm to crossmember mounting bolts with new flange bolt & washer p/n 06508844AA (Fig 1).
4. Torque new flange bolt & washer to 140 Nm (103 ft. lbs.).
5. Install belly pan (if equipped).
6. Check front alignment and steering wheel centering.
