February 2011

Customer Satisfaction Notification K39 Transmission Shifter Interlock Lever

2007 (LX) Dodge Charger, Magnum and Chrysler 300

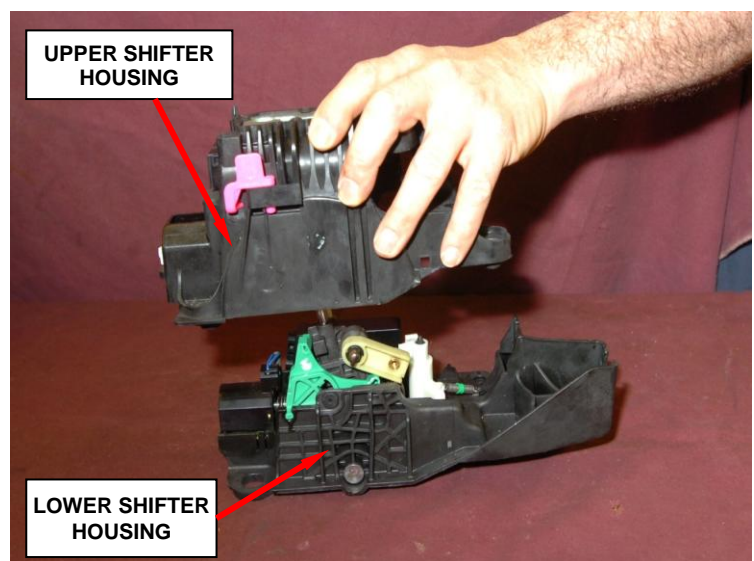
Figure 5 – Separate Upper Housing from Lower Housing

The transmission gear shift lever interlock return spring hook on about 28,800 of the above vehicles may break. A broken interlock return spring hook will result in the inability to move the gear shift lever out of the "PARK" position.

20. Partially separate the upper shifter housing from the lower shifter housing by prying on the three retaining tabs (Figure 4).
21. Disconnect the electrical connector located inside the shifter assembly.
22. Finish separating the upper shift housing from the lower shift housing (Figure 5).

23. Disconnect the interlock lever return spring at the pivot arm (Figure 5).
24. Remove and discard the pink interlock lever.
25. Install the new interlock lever onto the pivot shaft.
CAUTION: Do not apply any type of lubricant to the pivot shaft.
26. Connect the interlock lever return spring.
27. Place the upper shift housing into position and connect the electrical connector located inside the shifter assembly.
28. Snap the upper shift housing into place on the lower shift housing.
CAUTION: The shifter must not be in the “PARK” position when assembling the shifter.
29. Place the shifter assembly back into the vehicle.
