NUMBER: 18-031-07

GROUP: Vehicle Performance

Flash: Launch Performance / Driveability Enhancements

This bulletin involves selectively erasing and reprogramming the GPEC Powertrain Control Module (PCM) with new software.

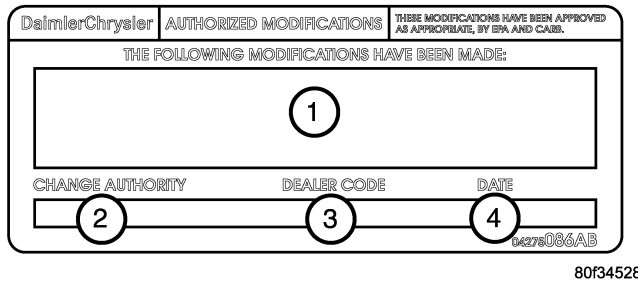
Fig. 1 AUTHORIZED MODIFICATION LABEL

- 9. Type the necessary information on the "Authorized Modification Label" p/n 04275086AB and attach near the VECI label (Fig. 1).
