**SUBJECT:** RAPID RESPONSE TRANSMITTAL/SERVICE ACTION #10-013  
Sunroof Mechanism Cover Loose and or Cracked

**INVOLVED VEHICLES:**

2009 (LX) 300/300C/Charger

2009 (LC) Challenger

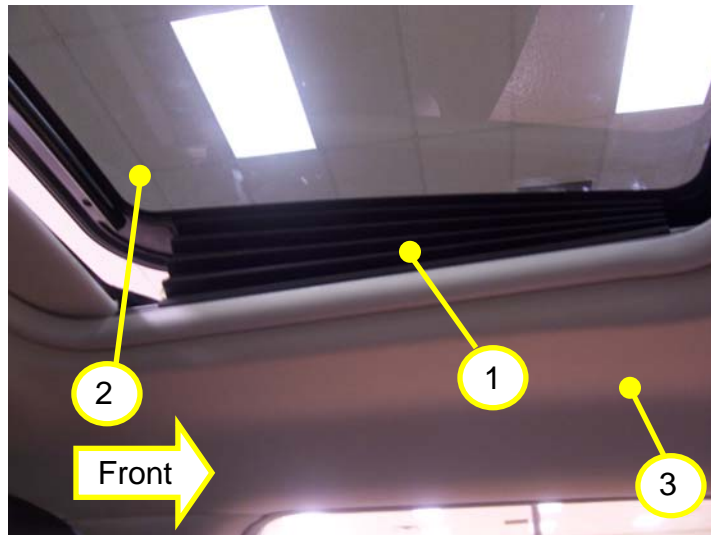
Figure 1- Sunroof Mechanism Cover

A small number of vehicles were shipped with sunroof mechanism covers that may be cracked, upside down or not fully seated. Dealers are required to inspect and if necessary replace the sunroof mechanism cover.

1. The 300 and Challenger sunroof mechanism covers are longer in length [325mm (12.8in)] than the Charger [300mm (11.8in)]. Confirm the mechanism cover lengths by measuring left to right. Were the lengths correct?
  - a. **YES**- Proceed to step 2.
  - b. **NO**- Proceed to the repair procedure.
2. Inspect the sunroof mechanism cover for cracks. Were there any cracks on the cover (Fig.1)?
  - a. **YES**- Proceed to the repair procedure.
  - b. **NO**- Proceed to step 3.

1	Sunroof Cover Mechanism
2	Sunroof Glass
3	Headliner

3. Can white lettering be seen on the cover from inside the vehicle?
  - a. **YES**- Proceed to the repair procedure
  - b. **NO**- Proceed to step 4.
4. Gently pull and push the cover forward and rearward. Was the cover fully seated?
  - a. **YES**- Return to dealer inventory
  - b. **NO**- Seat the cover into place by pressing the upper and lower portions of the cover to seat into place.

1. Remove the sunroof mechanism cover. Refer to the detailed removal procedures available in DealConnect> TechCONNECT under: Service Info> Body> Sunroof> Cover, Sunroof Mechanism> Removal.
2. Install the correct sunroof mechanism cover (based on vehicle type). Refer to the detailed installation procedures available in DealConnect> TechCONNECT under: Service Info> Body> Sunroof> Cover, Sunroof Mechanism> Installation.
3. Return the vehicle to dealer inventory.
